STORM EVENT OF OCTOBER 8-10, 1991

December 1991

**South Florida Water Management District
West Palm Beach, FL**

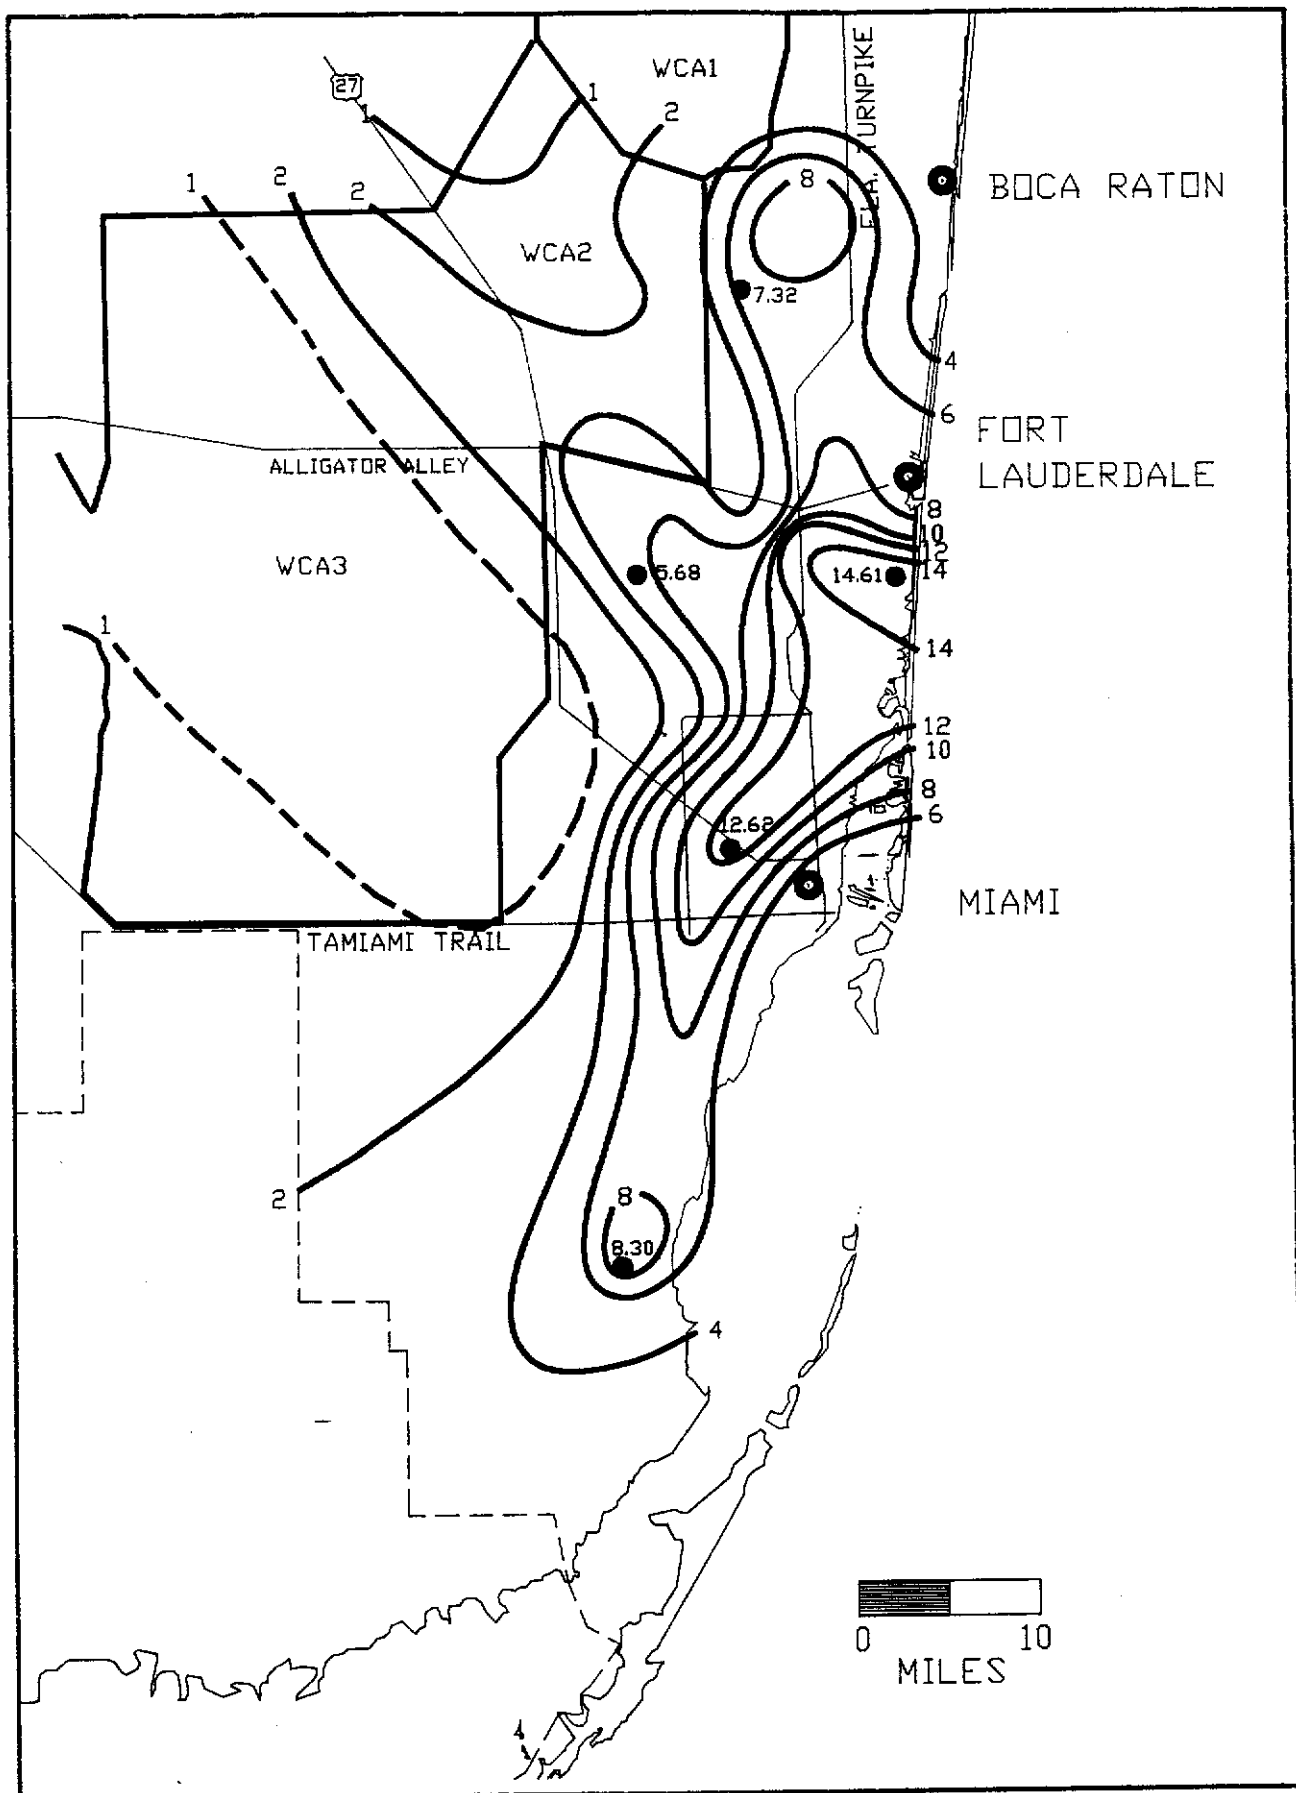
Figure 1. Isohyetal Map of the October 1991 Storm

The spatial distribution of the three-day storm is shown in Figure 1. The isohyets illustrate the areal variation of the storm, and indicate that the heaviest rains occurred near the coast, between Fort Lauderdale and Miami. Recorded rainfall amounts ranged between 0.2 and 15 inches, with the highest three-day total of 14.61 inches accumulated in Hollywood. Miami International Airport received a total of 12.76 inches. Although the major portion of the storm occurred between Fort Lauderdale and Miami, significant amounts of rain fell as far south as Homestead Air Force Base, recording 8.30 inches, and to the north, where Coral Springs received 7.32 inches during the 72-hour period. Rainfall decreased towards the west where less than 16 miles from the coast 5.68 inches were registered at the South Broward Drainage District gage. The locations of the recording stations (Figure A-1) and rainfall amounts used to develop the isohyetal map are presented in Appendix A.

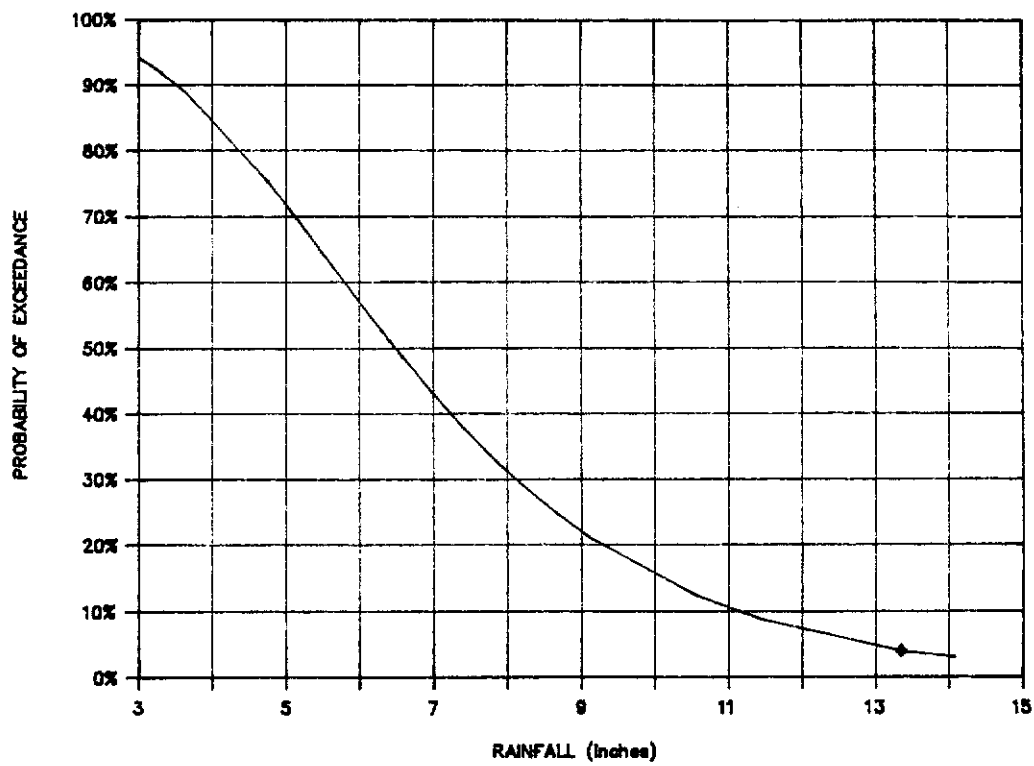
Figure 2. Three-Day Maximum Rainfall Frequency-Gill Realty Station, Broward County

Return periods for three-day rainfall amounts from Gill Realty and Miami International Airport stations were determined from the exceedance probability curves shown in Figures 2 and 3. These curves assume that the historical three-day maximum data follow a Gumbel extreme value distribution. The return period is found by first locating the three-day rainfall value on the Gumbel distribution curve. The ordinate associated with this point is referred to as the probability of that three-day rainfall being equalled or exceeded in any given year at that recording station. The reciprocal of the exceedance probability is equal to the return period of the rainfall depth. The Miami International Airport and Gill Realty gages recorded three-day rainfall depths having a probability of exceedance of approximately 4 percent, or a return period of 25 years. The three-day rainfall return periods for other locations (Table 2) were estimated from the isohyetal maps shown in District Technical Memorandum, Frequency Analysis of One- and Three-Day Rainfall Maxima for Central and Southern Florida, October 1990.

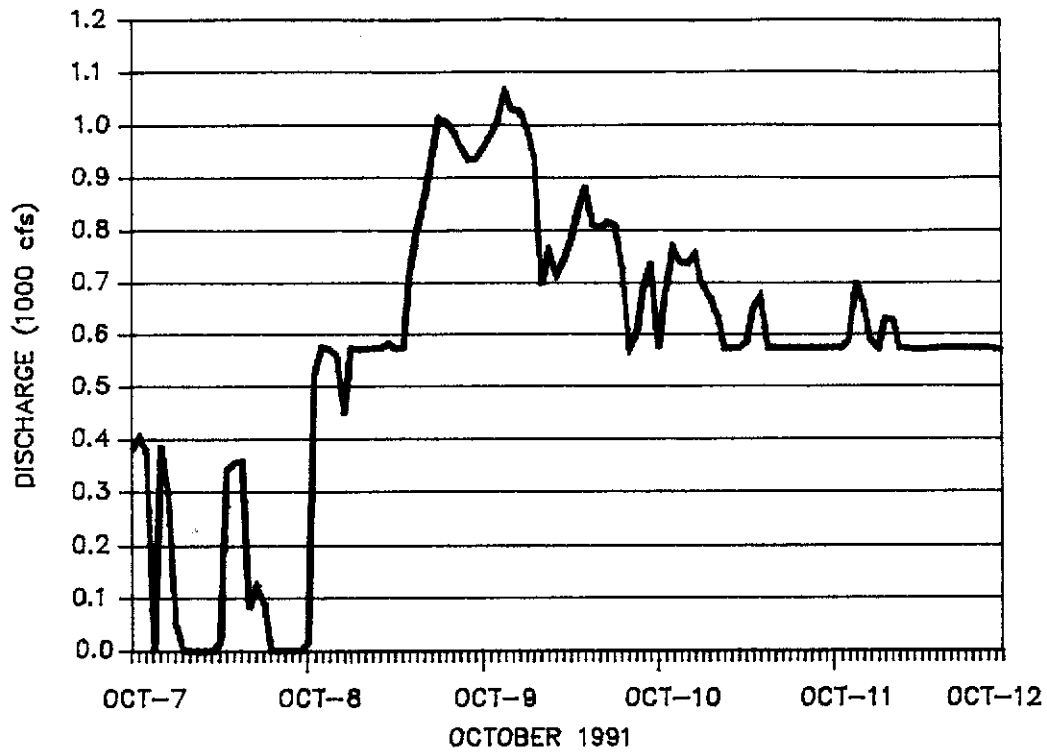
Figure B-21. Mean Hourly Discharges in C-11 Canal at S-13

The discharge hydrographs shown in Figures B-21 through B-26 reflect the operations of coastal structures. Normal flood control procedures dictate that coastal areas of Dade County receive priority drainage over the western areas. In conformance with this policy, all discharge moving eastward from the area west of Krome Avenue to C-4 or C-6, was terminated on October 8. This included diversions to the Northwest Wellfield which are normally controlled by Dade County utilities.

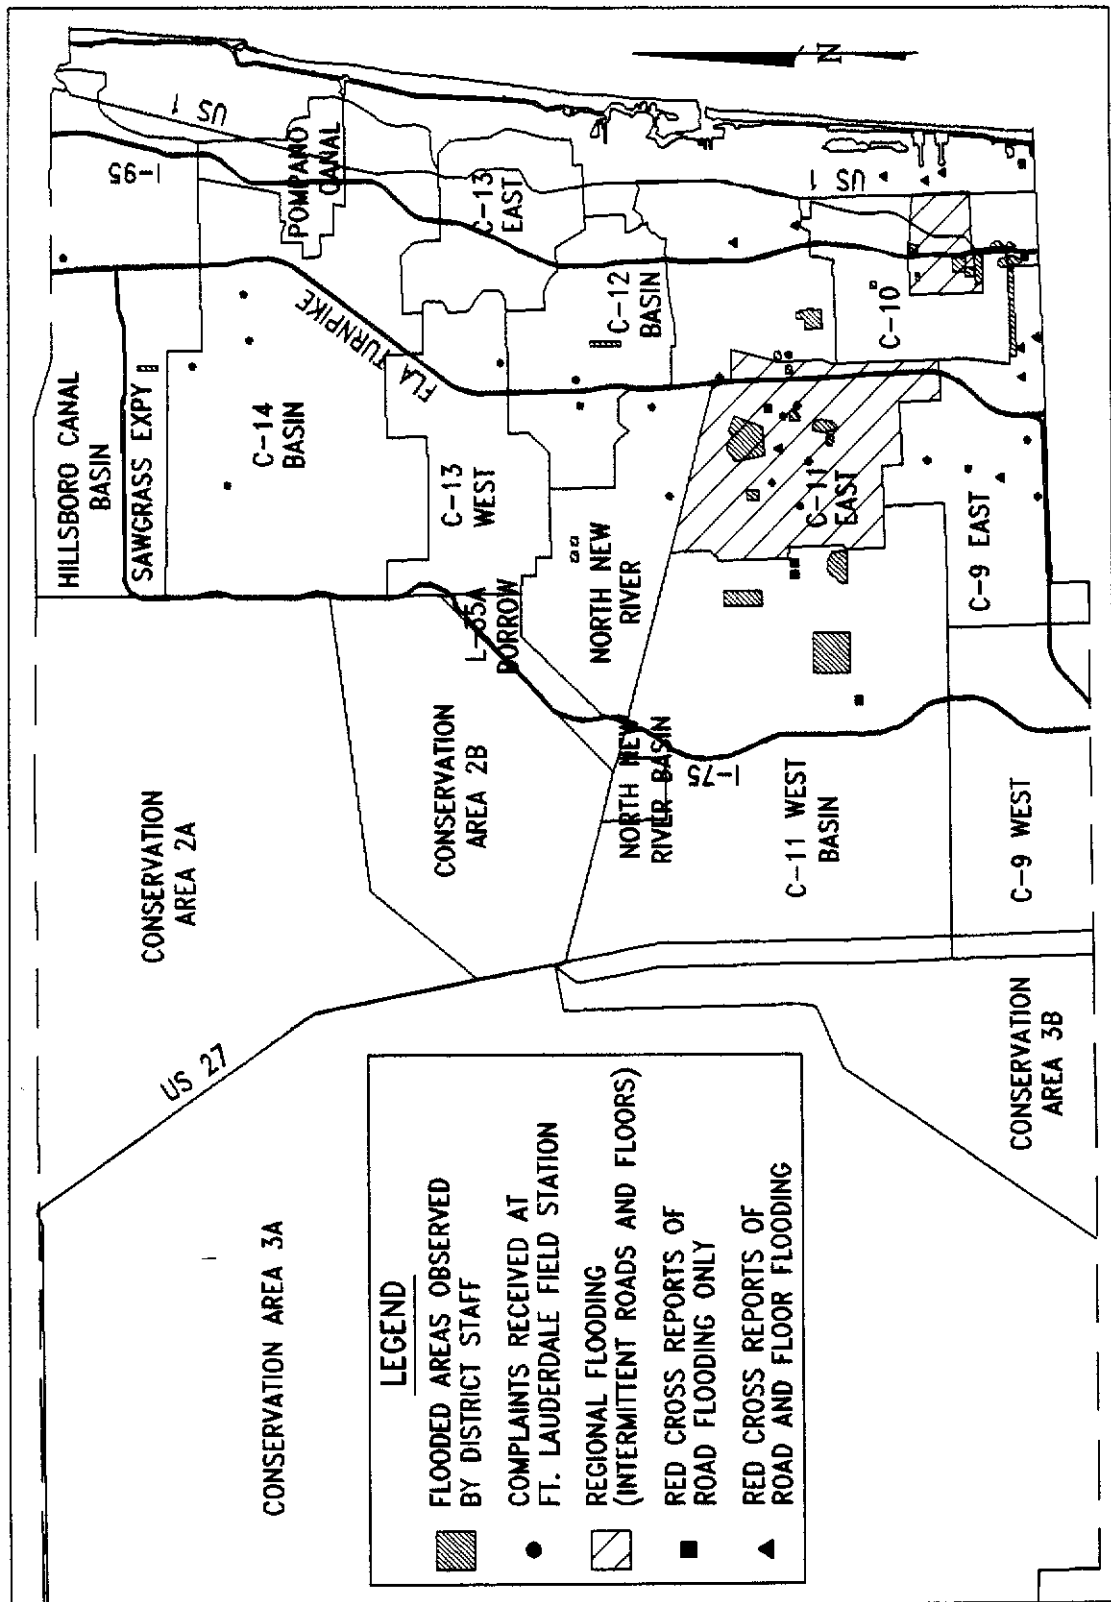
Figure C-1. Areas of Observed and Reported Flooding in Broward County

- a. Nova High School/University: Maintenance buildings and green houses were flooded [1].
- b. Emerald Isles Apartments: Parking and air conditioning units flooded to 16 inches [2].
- c. Majestic Groves subdivision: Streets and yards flooded up to building foundations [3].
- d. Little Ranches: Streets flooded [4].
- e. Davie Road and 52nd Street: Streets and floors in lower areas flooded [5].
- f. Davie Road area south of Griffin Road: Streets flooded [6].
- g. Shopping Center at 441 and Griffin Road: Parking lot flooded to 20 inches [7].
- h. SW 30 St/Rolling Hills Golf Course: Streets, yards and golf course flooded from 10 to 12 inches [8].

- r. Sunshine Acres: High water caused drainfield problems [18].
- s. Sunset Strip from NW 91 Avenue to NW 96 Avenue: Street and yard flooded to 6 inches [19].
- t. Pine Island Rd./Sunset Strip intersection: Flooded to 20 inches, street closed [20].
- u. Godfrey Road at Wiles Road: Streets and paddocks flooded to 10 inches [21].
- v. Miramar Parkway east of 441: Street closed due to flooding, depth unknown [22].
- w. Broward Resource Recovery Plant: Water inside of the ash landfill breached the surrounding dike. There was no discharge of water offsite, and the breach was repaired within one day. FDER kept on top of this [23].
- x. NW 39 Avenue from 4 Court to Seventh Street: Streets and yards flooded to 12 inches. Homes flooded to 4 inches [24].

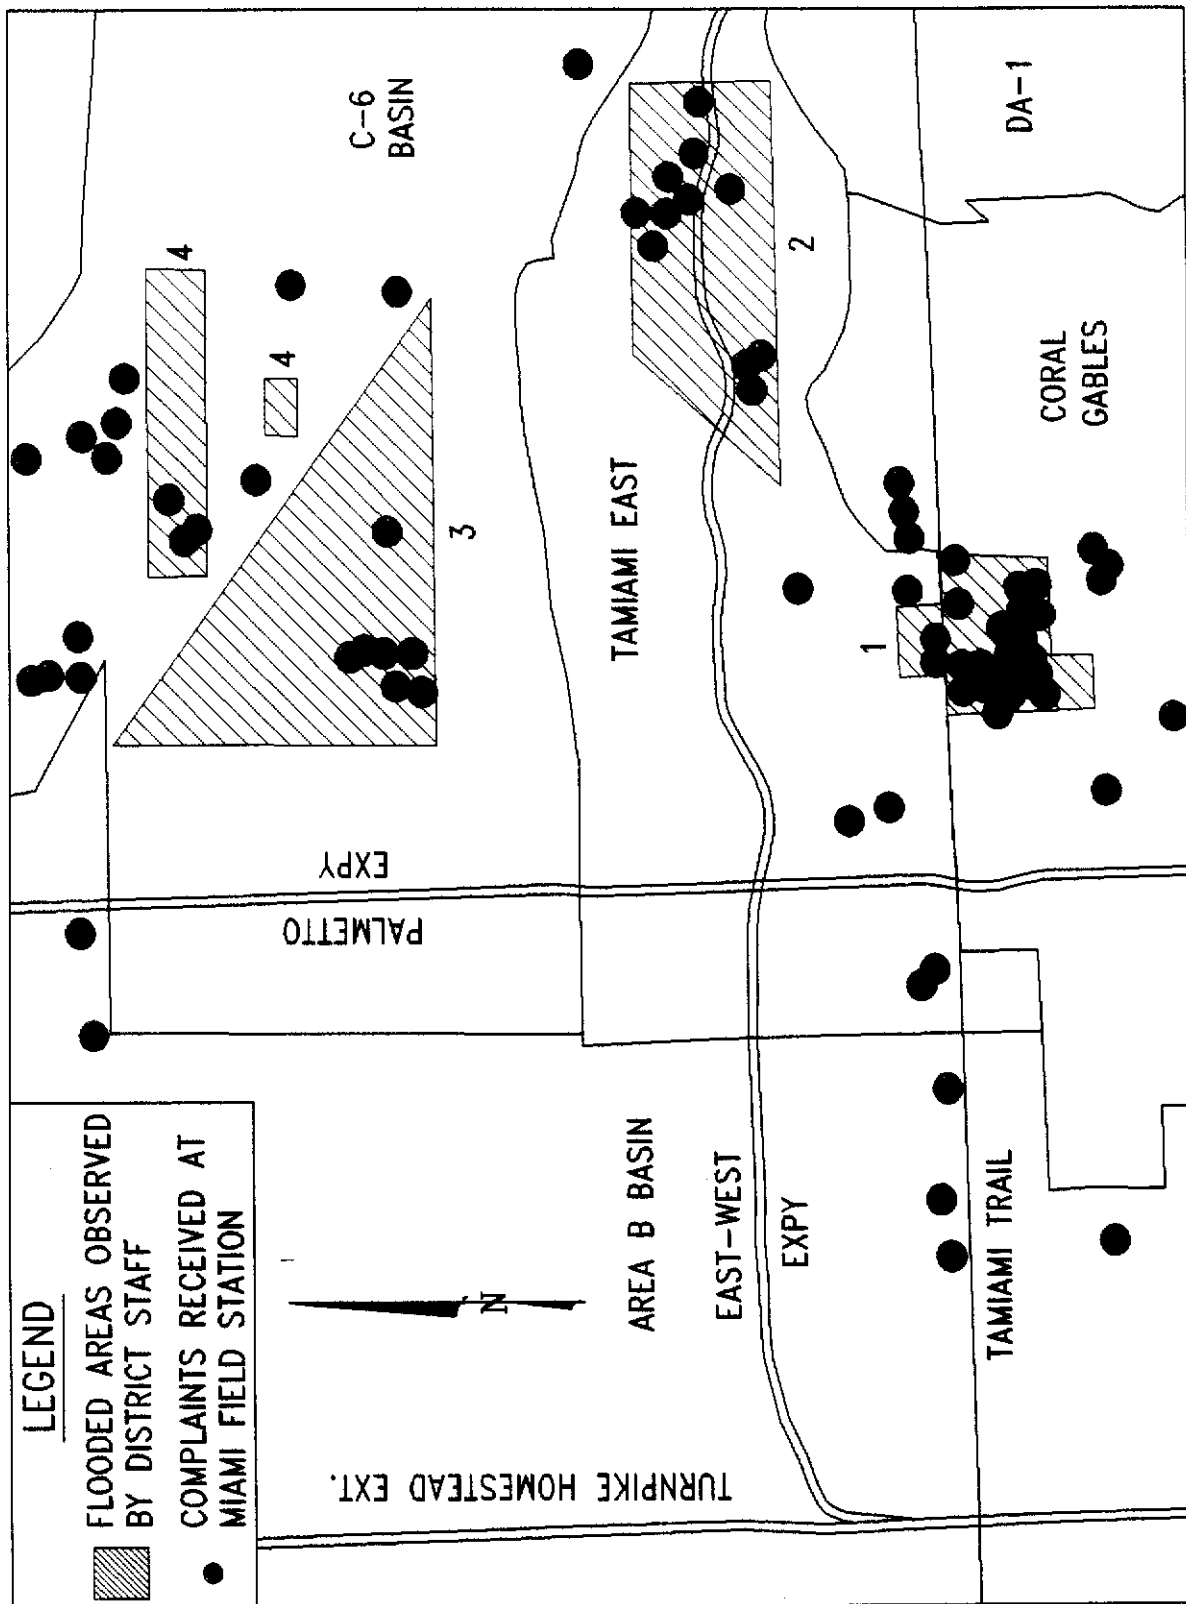
Figure C-6. Areas of Observed and Reported Flooding in Central Dade County

Affected areas of Dade County were observed by Field Engineering staff and Miami field station personnel by helicopter, and flooding was documented on video tape. Additional inspections were performed by Miami station personnel on the ground. Primary areas of documented flooding in Dade County are described below (numbers in brackets correspond to location on figures C-5 and/or C-6):
